Report No. FAA-RD-78-122

TESTS OF CRASH-RESISTANT FUEL SYSTEM FOR GENERAL AVIATION AIRCRAFT

DECEMBER 1978

FINAL REPORT

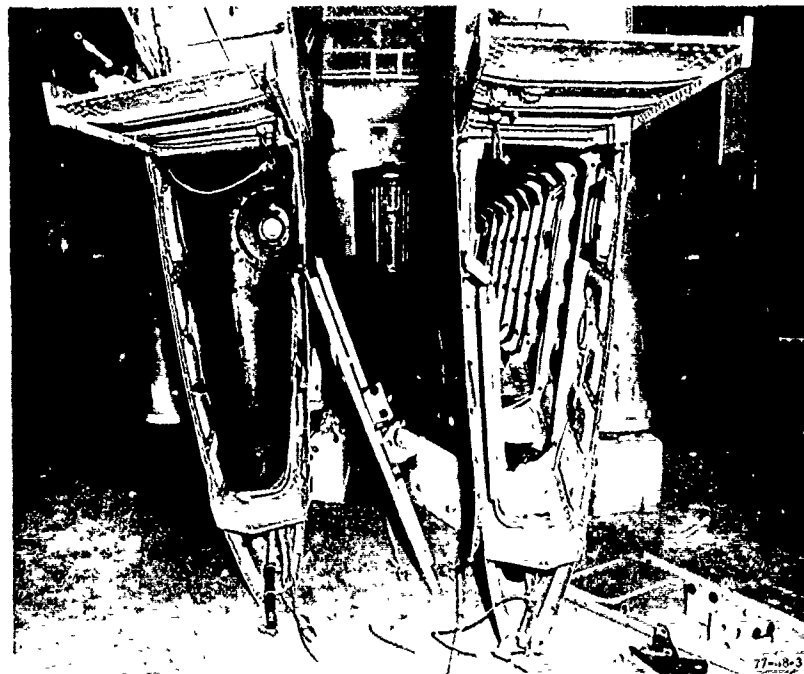
FIGURE 3. INSTALLATION OF TWO-PLY FUEL TANK

- ① EQUIV. TO MS33656-8
- ② EQUIV. TO MS33514-12 MOD.
- ③ EQUIV. TO MS33649-12

The crashworthy tanks were installed by removing the bulkhead rib at the wing root after the wing was removed from the aircraft. The tank was slid into the wing, after which the rib was riveted back in place, and the wing was reinstalled. Referring to figure 3, it is seen that the tanks occupy the wing leading edge. No modifications were done on the wing where the filler flange fittings, access, and gauge fittings were located. The frangible couplings (figure 4) were installed at the fuel outlet and vent fittings. As bulkhead ribs interfered with these fittings, 2-inch diameter clearance holes were cut in the ribs. To provide a more severed operating condition for the couplings, aluminum tubing was used in lieu of the flexible tubing normally used for fuel lines. Acuating arms were installed to impact these lines when the arms contacted the ground during the crash (figure 5).

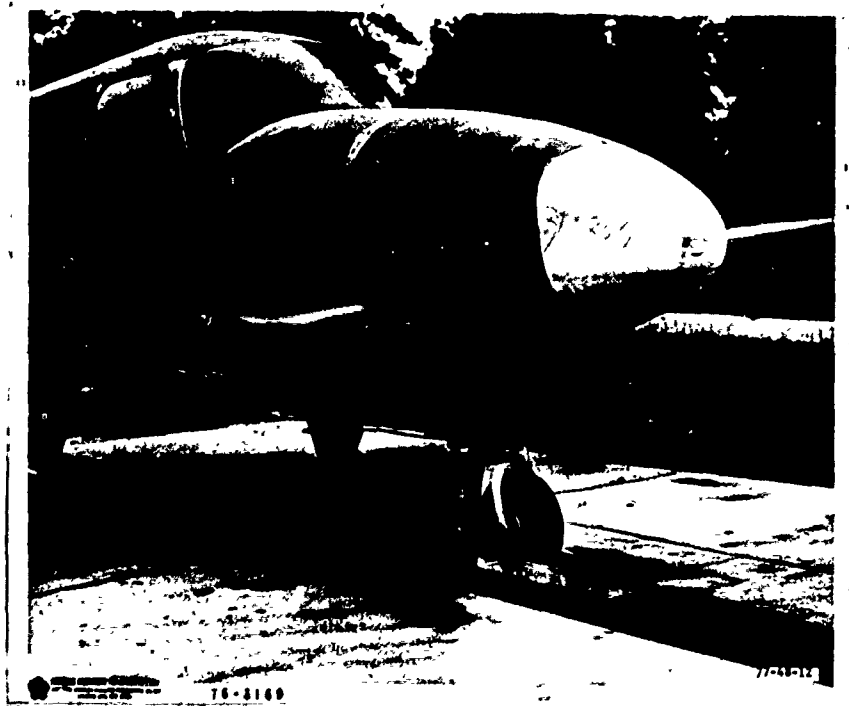
FIGURE 6. NOSE GEAR TOWING ATTACHMENT

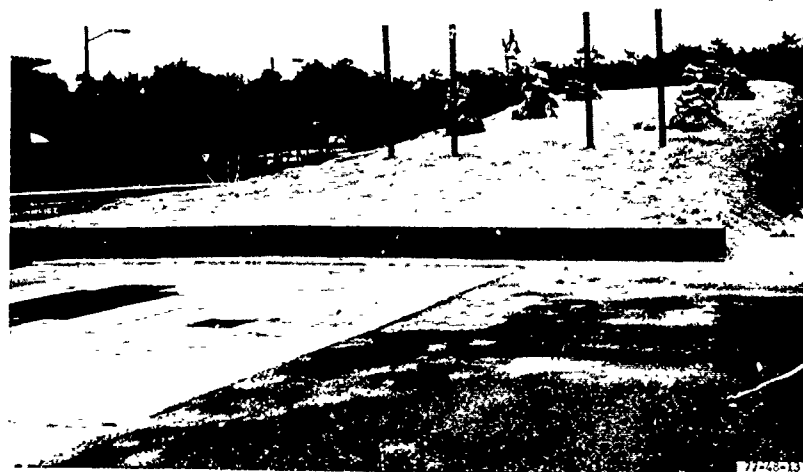
FIGURE 7. CRASH TEST SITE

from the wings. Spoilers were installed along the upper wing surface to keep the airplane from flying. At a distance of 10 feet from the I-beam, poles were sunk into the hill to a depth of 18 inches. These poles were spaced symmetrically off the centerline of the hill, at 42 inches and 108 inches each. The poles were hollow mild steel tubing, 4.375-inches outside diameter, 0.188-inch wall thickness and were 10 feet in length. Small rock piles were located on the hill to further increase the severity of the crash condition (figure 7 and 8). There are no standards in general use for a crash site as is used in this type of test; hence, the selection of the type of poles, rocks, and hill were selected to produce a destructive environment to the fuel tank location. The crash site was intended to be at least as severe as a crash at an airfield involving airport structures such as approach lights.

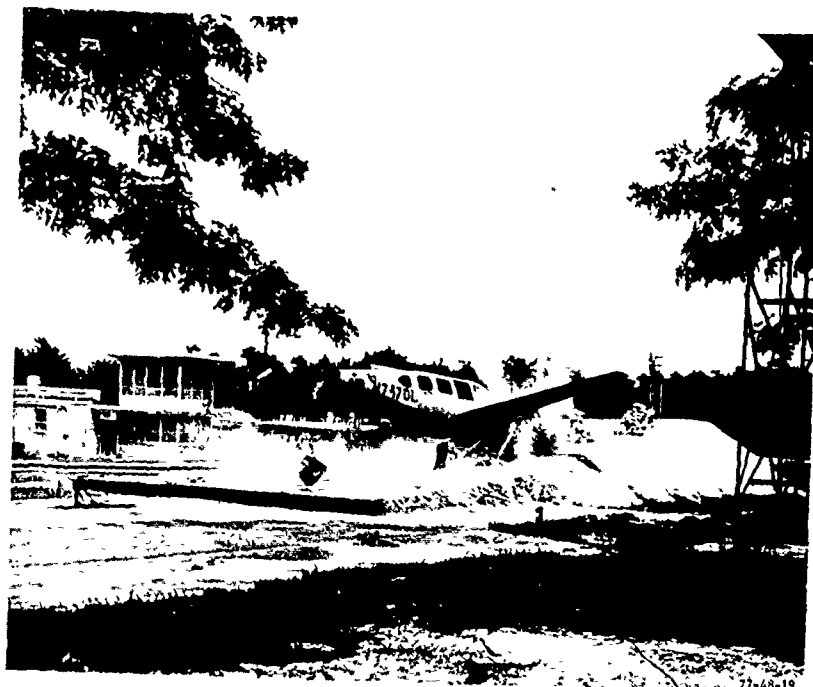
FIGURE 13. AIRCRAFT IMPACT, TEST 2, (NOTE WATER SPRAY FROM RIGHT WING)

Test 2 compared the existing bladder cell (right wing) with a two-ply crashworthy cell. The two-ply tank survived the 93-ft/s impact with no damage, but the original bladder cell failed catastrophically, spraying out its contents almost instantaneously. The cell failed predominantly by tearing (figures 13 through 19). During impact, the aircraft rotated counterclockwise about its center of gravity as viewed from above, as the forces delivered to the left wing were higher due to the stiffening effect of the two-ply tank. It came to rest at about a 30° angle. Acceleration levels are shown in figure 20.

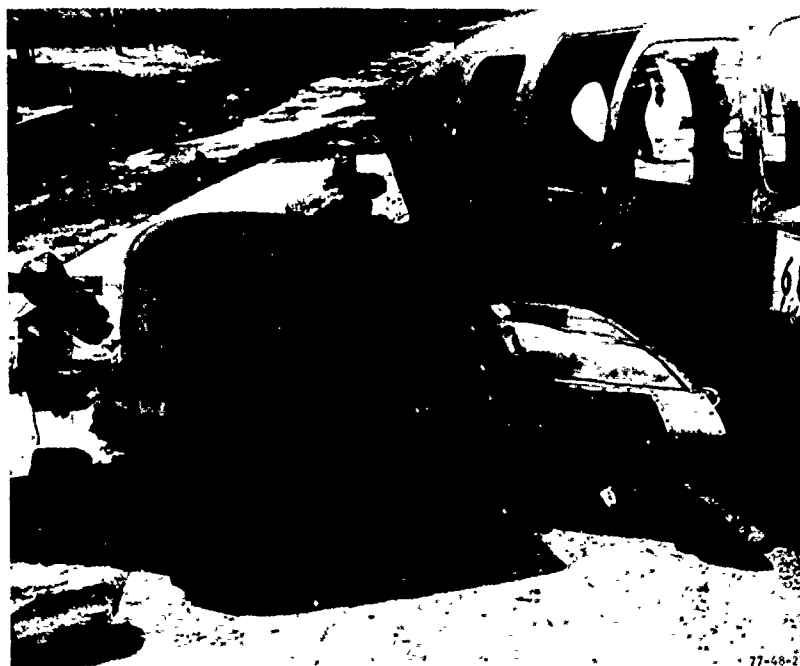
FIGURE 15. DAMAGE TO RIGHT WING, ORIGINAL AIRCRAFT BLADDER CELL, TEST 2

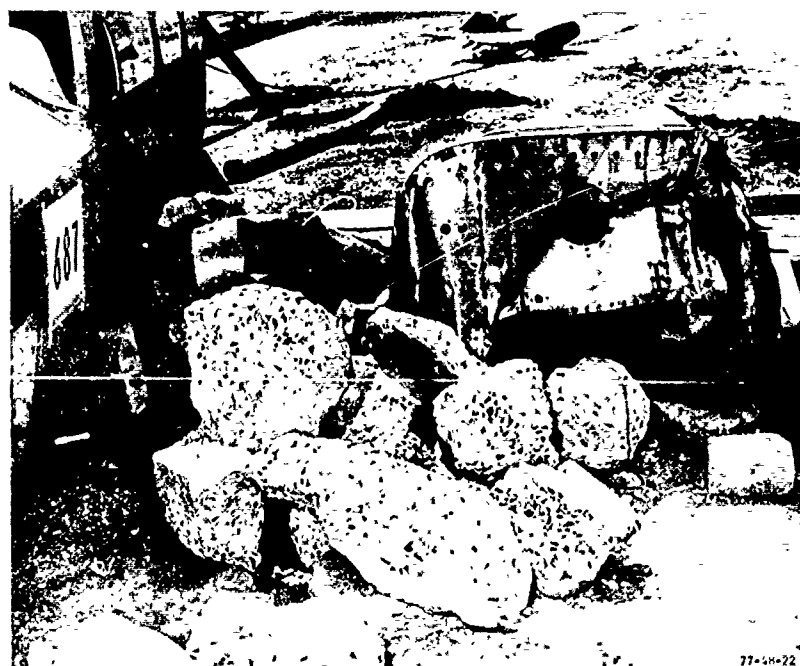
FIGURE 16. DAMAGE TO LEFT WING, TWO-PLY FUEL TANK, TEST 2

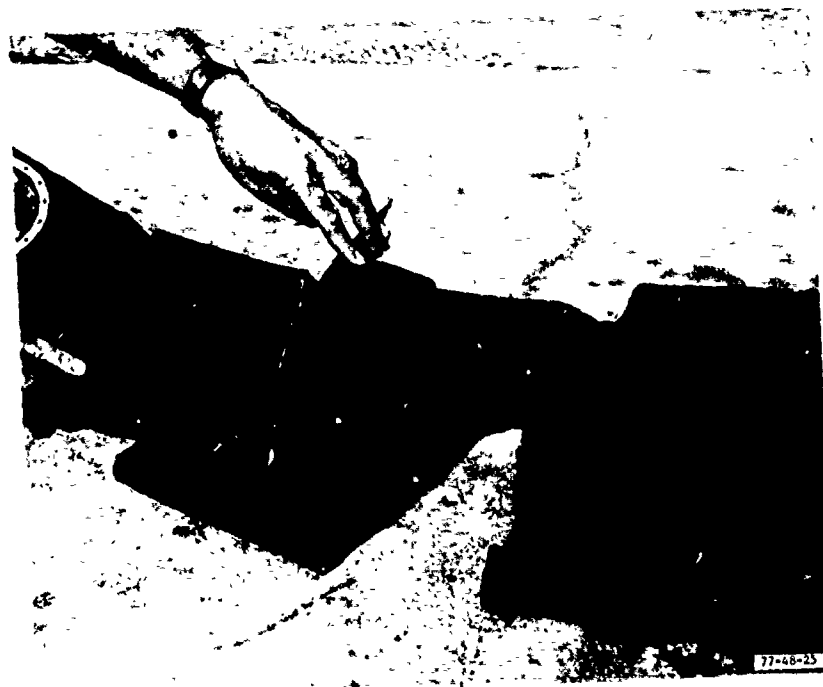
FIGURE 19. DAMAGE TO REGULAR AIRCRAFT CELL DUE TO POLE IMPACT (OUTBOARD)

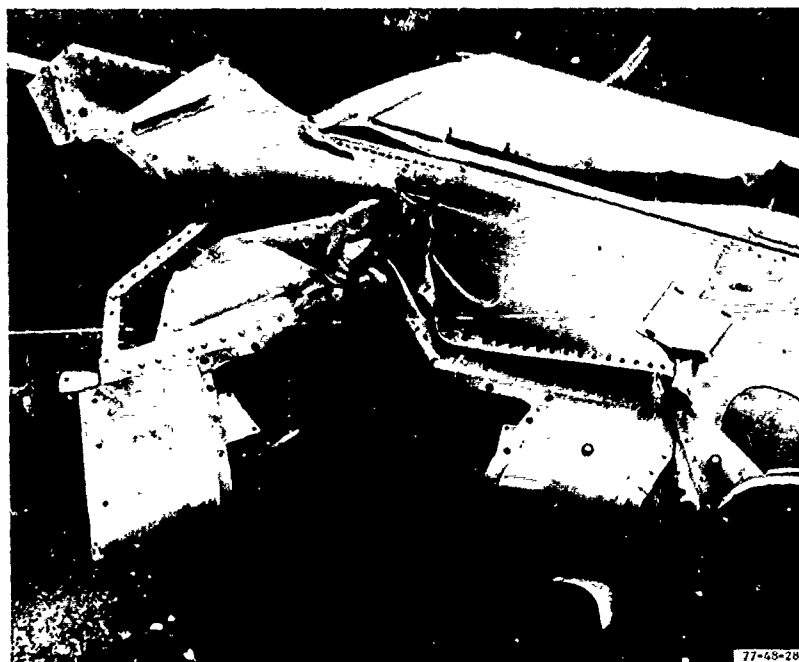
FIGURE 22. DAMAGE TO RIGHT WING, TEST 3

Test 3 was performed to evaluate the performance of a 12.75 oz single-ply tank installed in the right wing. A two-ply tank was run concurrently. Both of these tanks survived the 95-ft/s impact with no damage discernable to a visual inspection (figures 21 through 23). Acceleration levels are shown in figure 24.

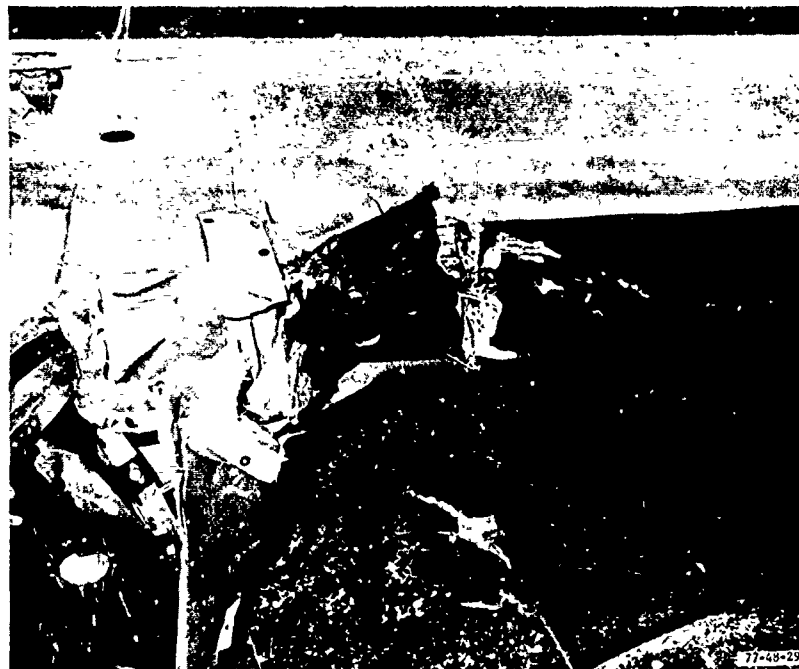
FIGURE 23. EFFECT OF ROCK IMPACT, TEST 3

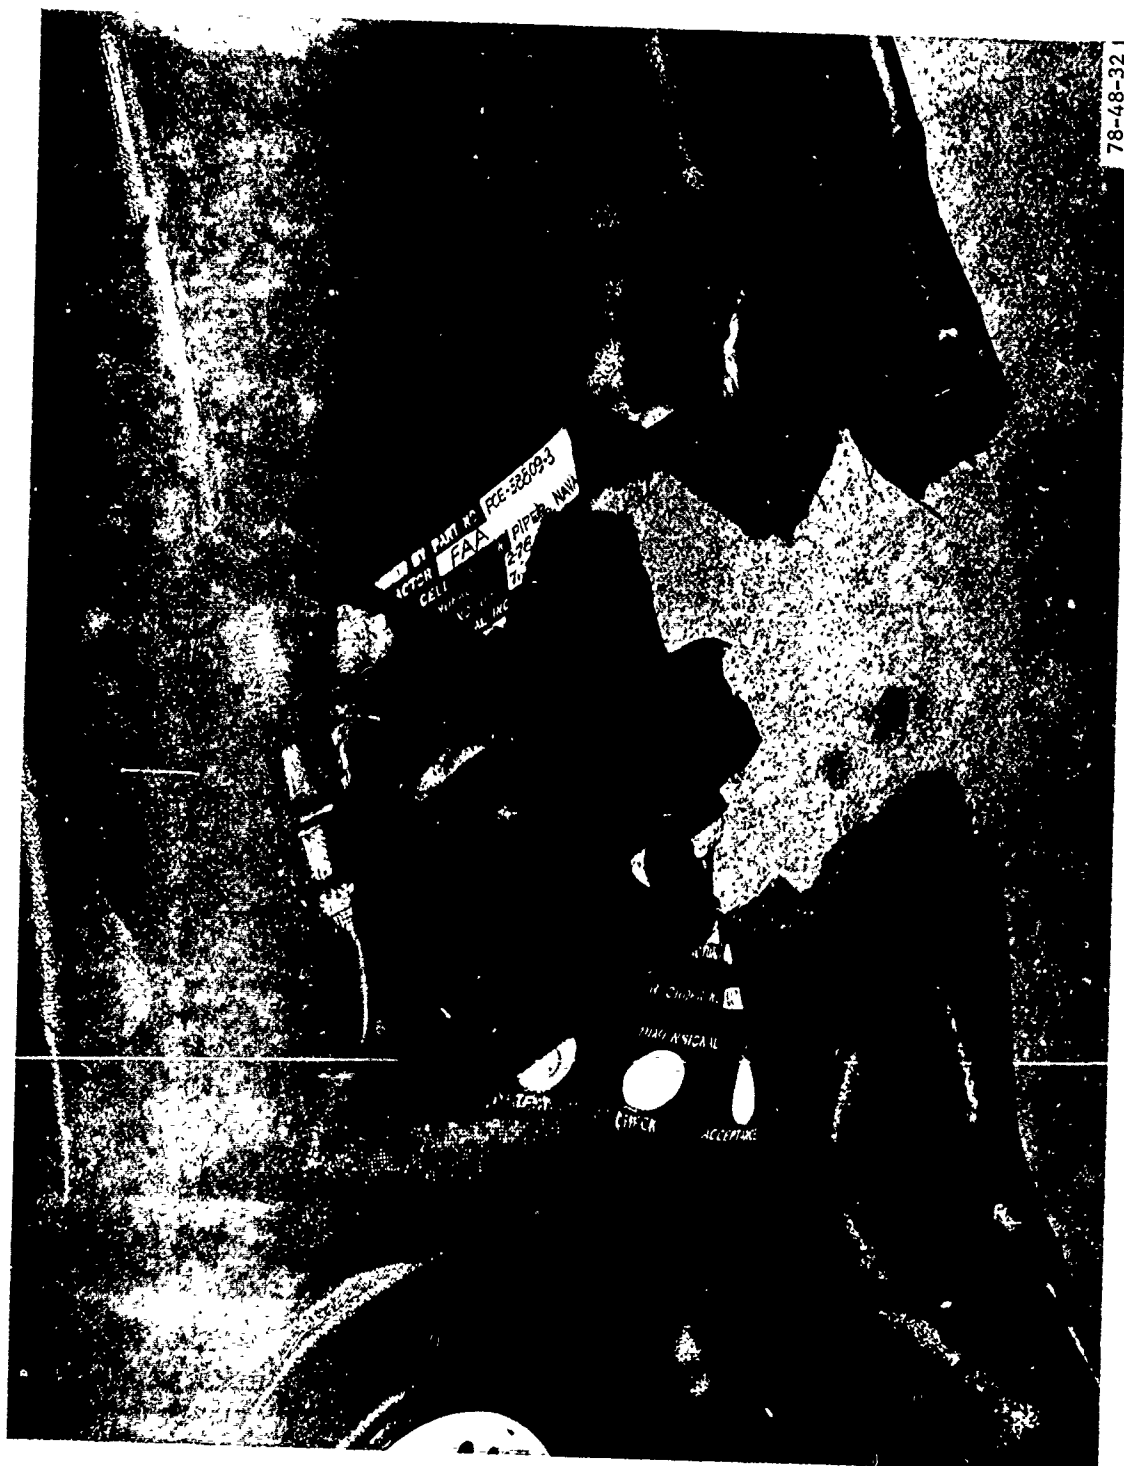
78-48-32

FIGURE 26. DAMAGE TO INBOARD AREA OF 5.5 OZ TANK

Test 4 was run with a single-ply 8.0 oz tank in the right wing and a single-ply 5.5 oz tank in the left wing. At the impact speed of 95 ft/s, both tanks failed. The 5.5 oz tank failed by tearing, which propagated extensively (figures 25 to 27). The 8.0 oz tank was only slightly damaged, the tears were limited to less than 2 inches and

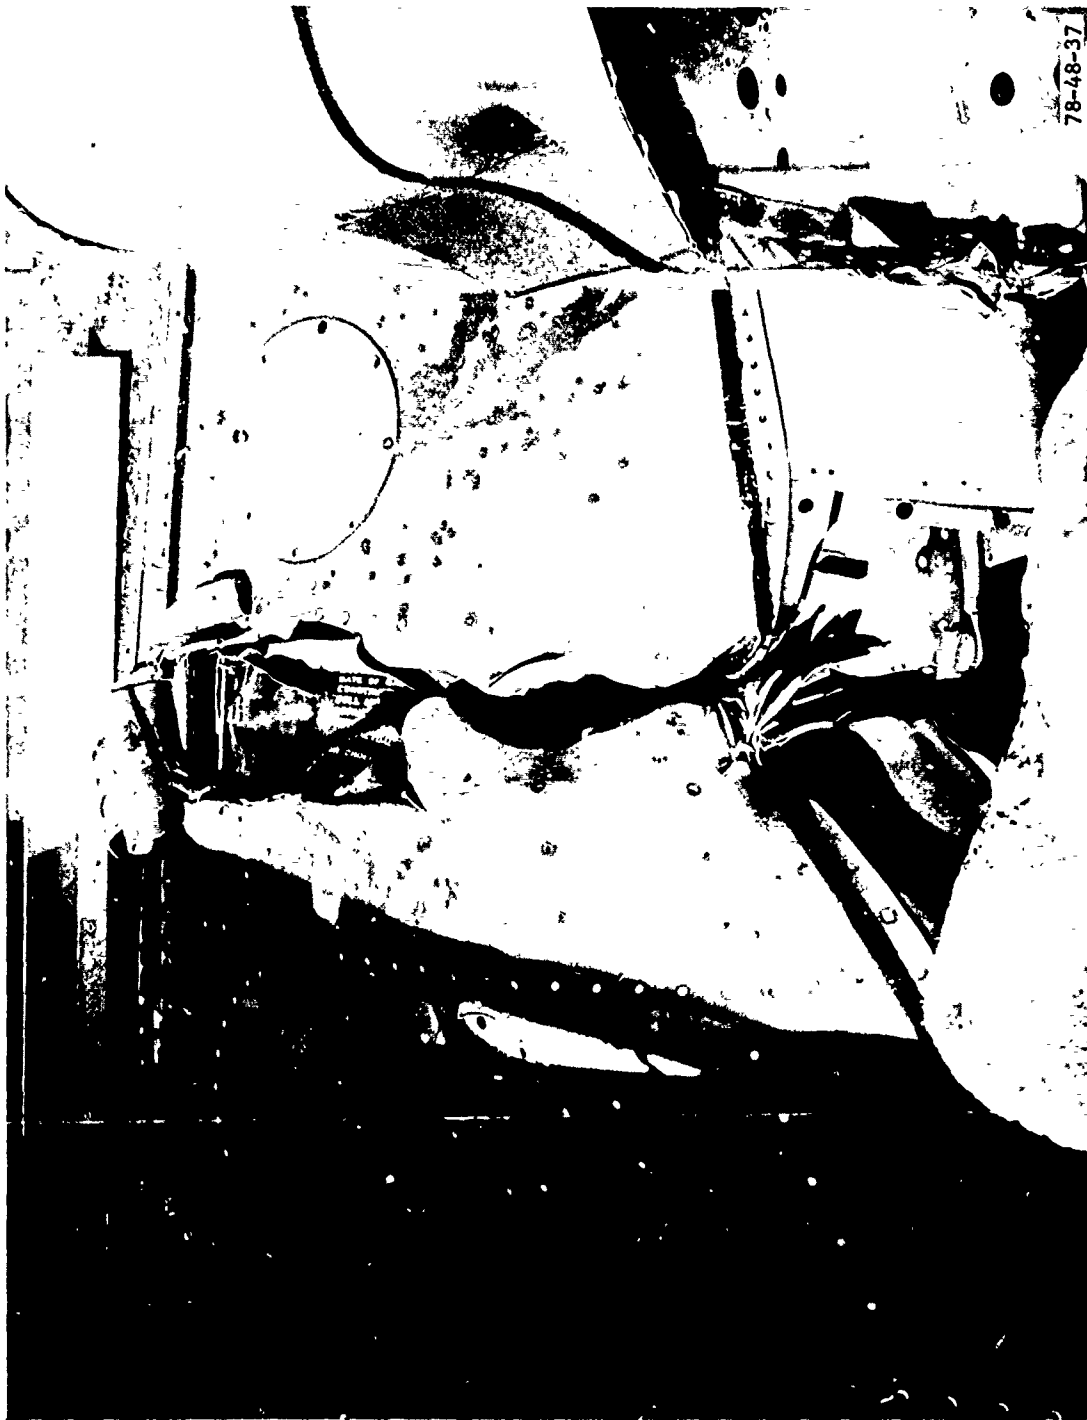
FIGURE 31. DAMAGE TO INBOARD LEFT WING

occurred in three areas (figures 28 to 30). Due to instrumentation problems, acceleration data were not obtained. Refer to figures 31 through 34 for structural damage.

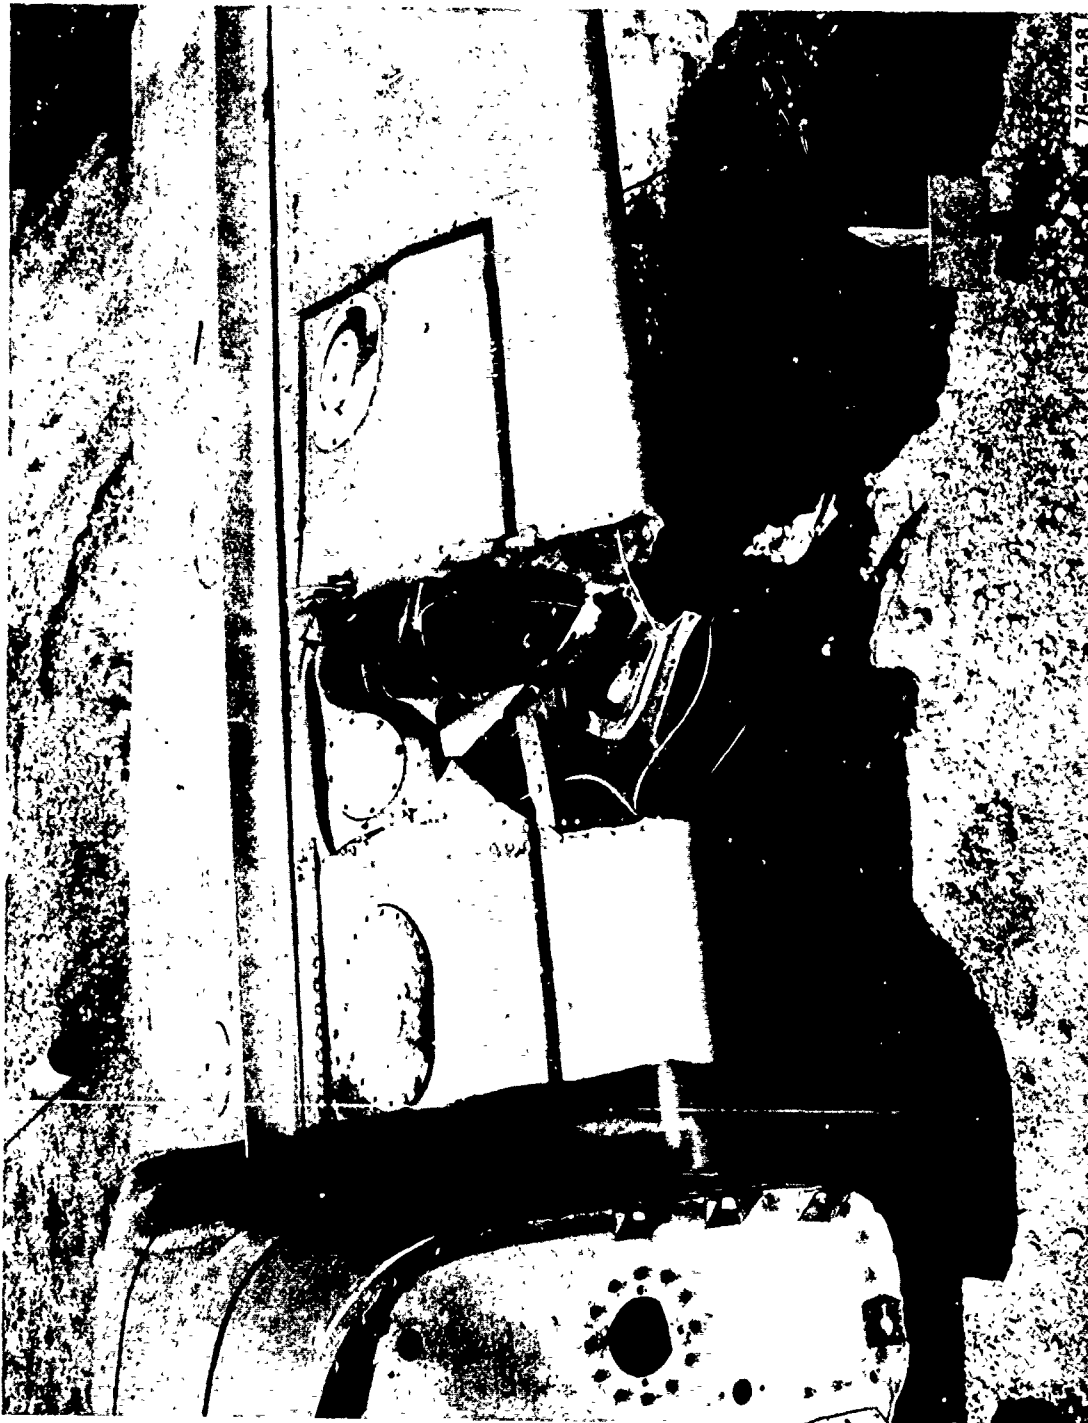
FIGURE 32. DAMAGE TO OUTBOARD LEFT WING

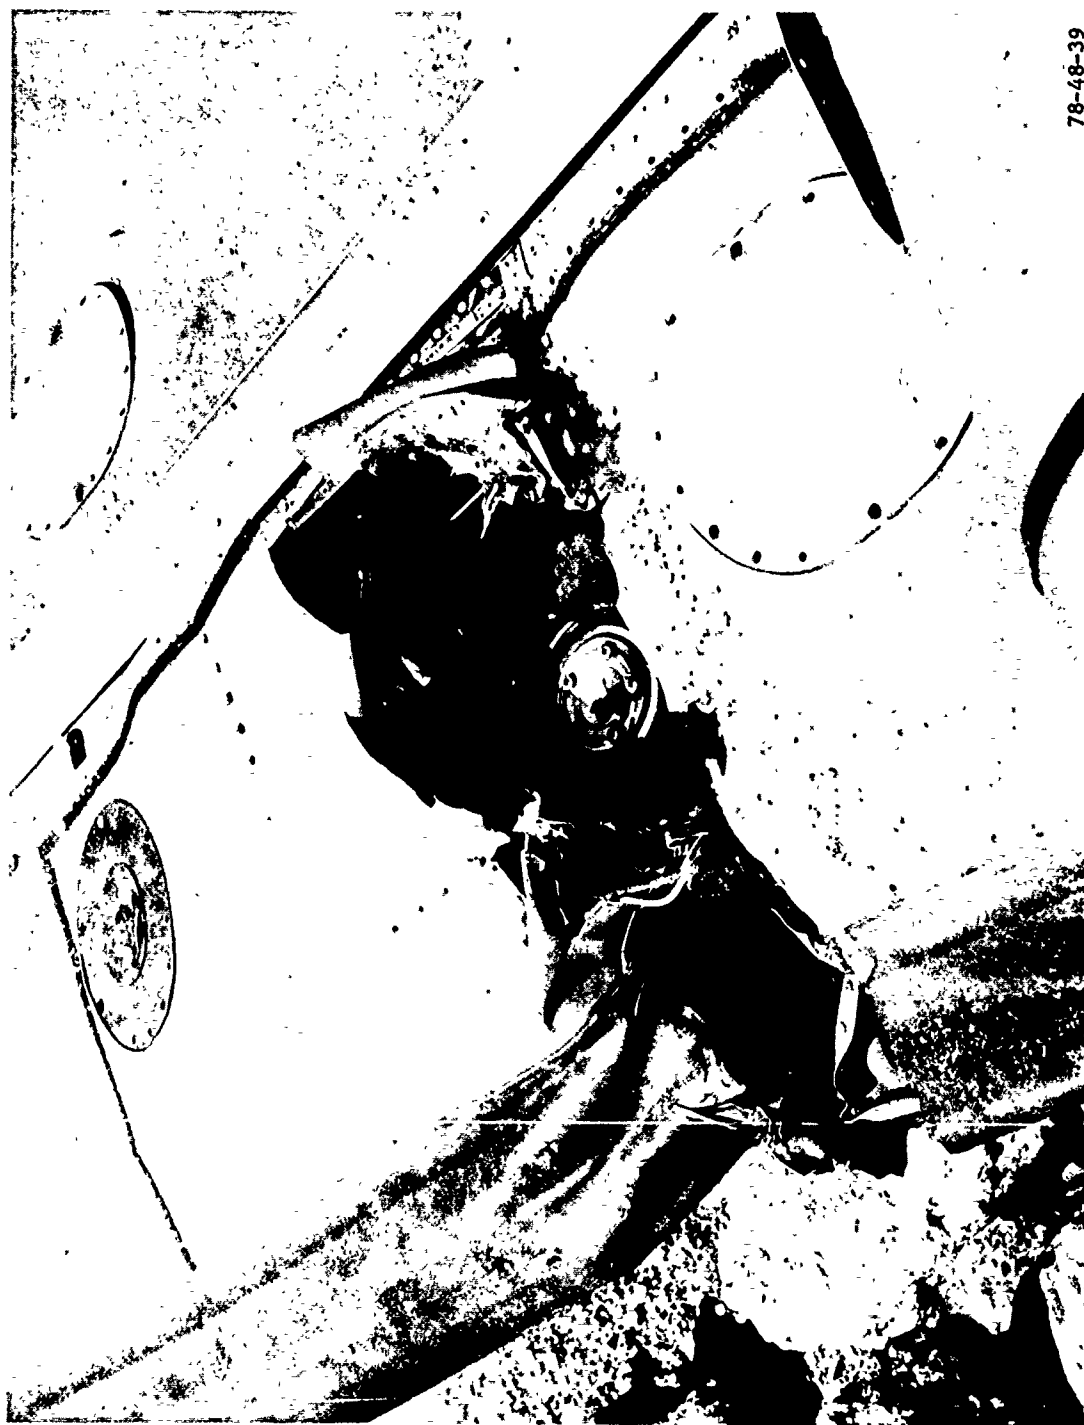
78-48-39

FIGURE 33. DAMAGE TO OUTBOARD RIGHT WING
